NEXT GENERATION BEST PRACTICE for fluid contamination control

Equipment: CAT 777D

Client: Northern Alberta Oil Sands Mine

Mag-Shield® contain debris and prevent spread after torque converter failure for CAT 777D truck.

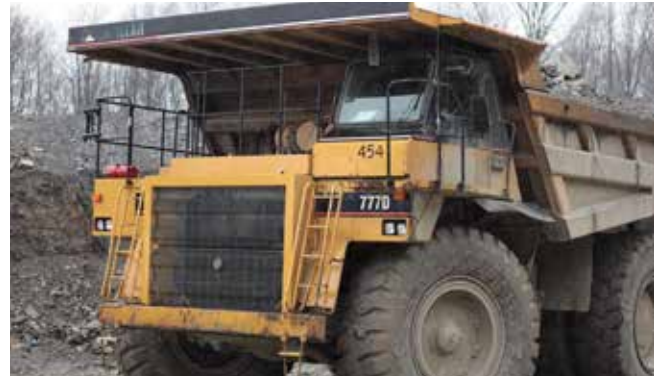
Side-by-side comparison of new **Mag-Shield®** to those that were removed from the CAT 777D post torque converter failure. All the particles on the dirty **Mag-Shield®** were prevented from continuously circulating through the system.

Following the failure, the hydraulic tank was drained, and all 4 **Mag-Shield®** were removed and weighed before cleaning and analysis. It was determined that 1.717kg (3.78 lbs) of material was captured by **Mag-Shield®** which would have otherwise flowed throughout the system and caused additional damage. **Mag-Shield®** made cleaning the hydraulic system faster and more effective. Post failure clean up is made possible as **Mag-Shield®** continues to clean residual contaminants from the system when the truck is put back into service. Follow-on failures were mitigated, and significant savings were observed by the truck owner.

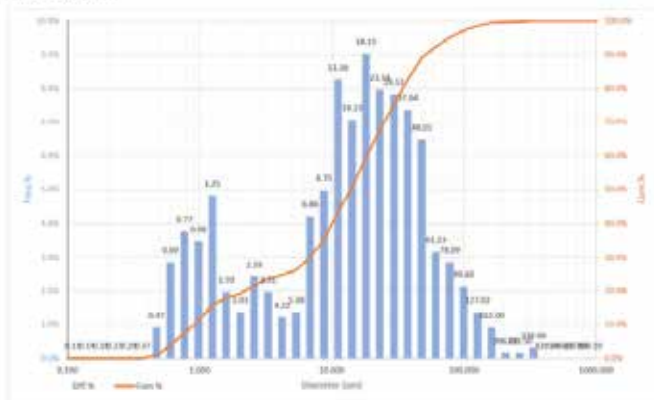
Particle Size Graph

Moreover, a sample from the **Mag-Shield®** with accumulated particles underwent scanning electron microscopy analysis conducted by SEMx Inc. The results showed a particle distribution of approximately 57% between 5µm and 40µm (particles that may not be captured by CAT Regular Efficiency filters), with an additional 26% of the captured particles being under 5µm (particles that may not be captured by CAT Ultra High-Efficiency filters). In contrast to OEM filters, **Mag-Shield®** serves as a valuable complement to OEM systems, efficiently capturing and retaining these ferrous particles and preventing their circulation throughout the system. It's worth noting that OEM filters, while effective in many aspects, may face challenges with smaller particles or in scenarios of high contamination, possibly triggering bypass operation.
